Evaluation of Stainless Steel Reinforcement in Bridge Decks

Follow up and Final Report

RI00-027

By
John D. Wenzlick, P.E.
Missouri Department of Transportation

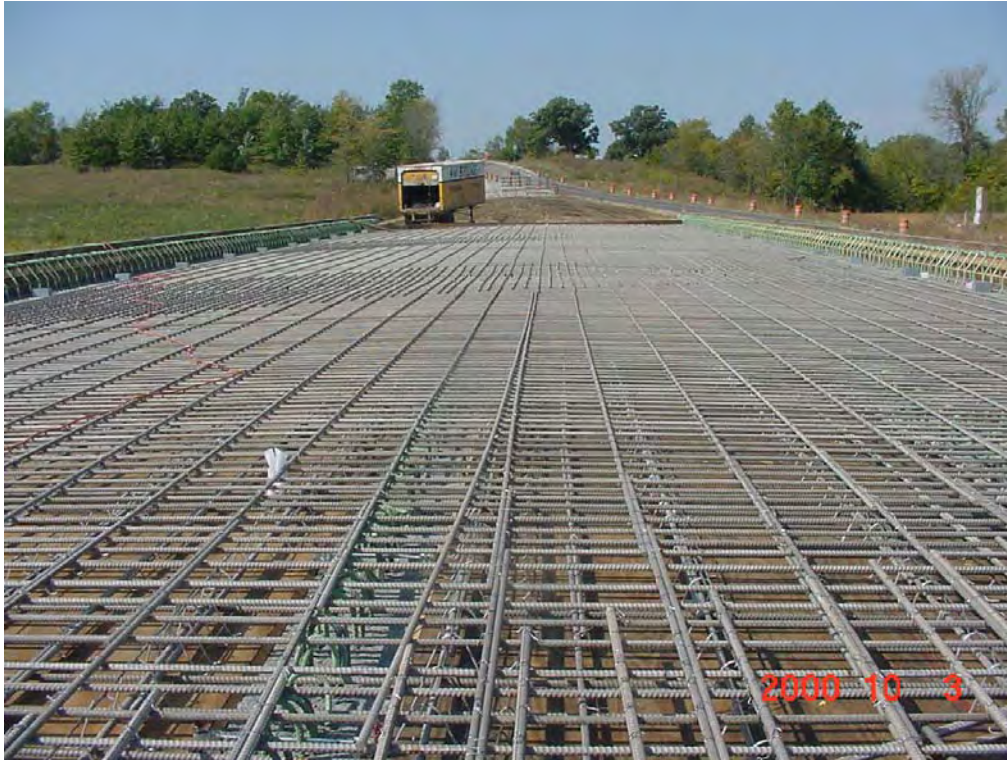
MoDOT is using innovative materials to design longer lasting reinforced concrete bridge decks. Stainless steel reinforcement has greater corrosion resistance than that of the conventional reinforcement. In this project, bridge A6059, the first in Missouri utilizing stainless steel reinforcement in the deck (see Figure 1) was completed in 2001.

Figure 1. Stainless Steel Reinforcement of Bridge A6059

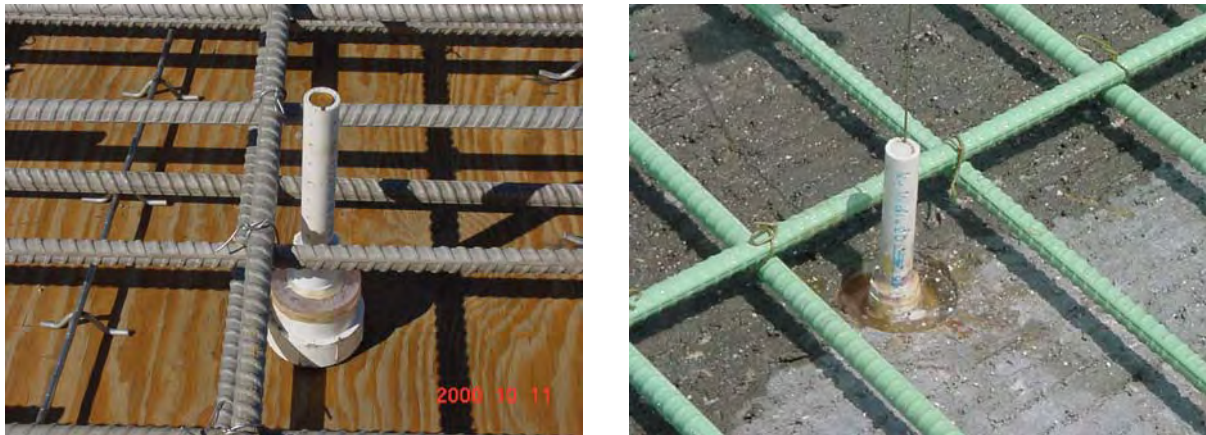
Figure 2. Sensor Housings Installation

An evaluation of the constructability and performance of stainless steel reinforcement was conducted. The bridges will be researched utilizing non-destructive tests to monitor salt application and chloride penetration in correlation to presence of (or lack of) corrosion. Fiber optic chloride sensors were incorporated into both bridge decks. Ten sensors were set on each bridge at different horizons. The sensor housings were installed during the deck construction before concrete was poured. See pictures in Figure 2 for the installation of sensor housings. The picture on the left is for the stainless steel bridge deck, and the one on the right is for the epoxy coated rebar bridge. Cylinders were taken to establish the compressive strength of the concrete for each bridge. Cylinders were also taken and tested for chloride permeability of both bridges according to AASHTO T277. Chloride samples were taken from the cylinders to get a base line chloride content of the concrete. These original properties (in some cases measured at 1 year old) of the concrete are listed in Table 1. Fiber optic chloride sensors were installed into the sensor housings shortly after the bridges were open to traffic. In addition, half-cell potentials were taken and will continue to be taken to determine corrosion rates on the bridge containing stainless steel reinforcement.
